An Assessment of Post Tsunami Restoration and Conservation Initiatives in Coastal Stretch of Matara

IUCN-Sri Lanka Country Office

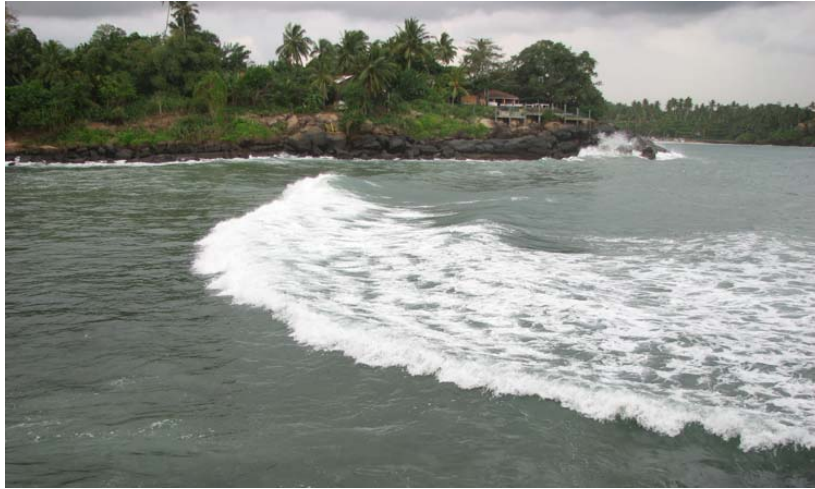
Rocky beach and the high wave actions in the Dewundara coastal area

The coastline of the Dewinuwara Divisional secretariat area is also composed of moderate to small sized barrier beaches and these beaches are also intersected in places by rocky headlands which form bays. This coastline faces heavy ocean current and high wave action, especially during the southwest monsoon period. Most parts of the coastal line are not suitable for the replanting program due to the presence of rocky beaches.

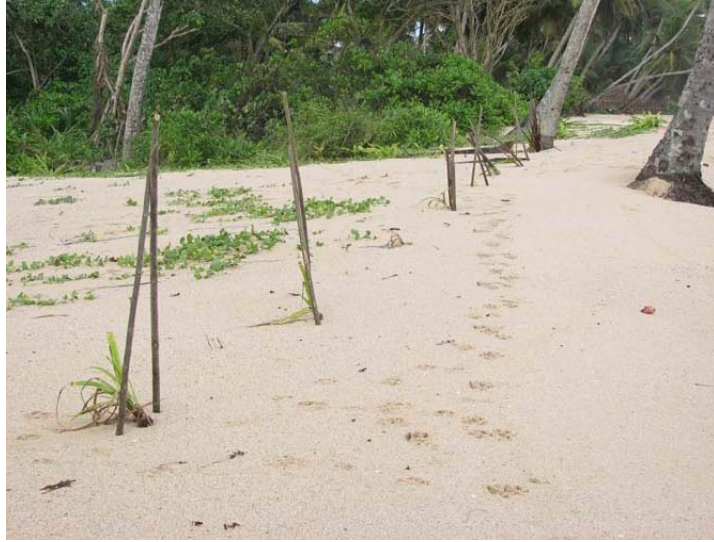
Poorly planted *Pandanus* washed by sea water

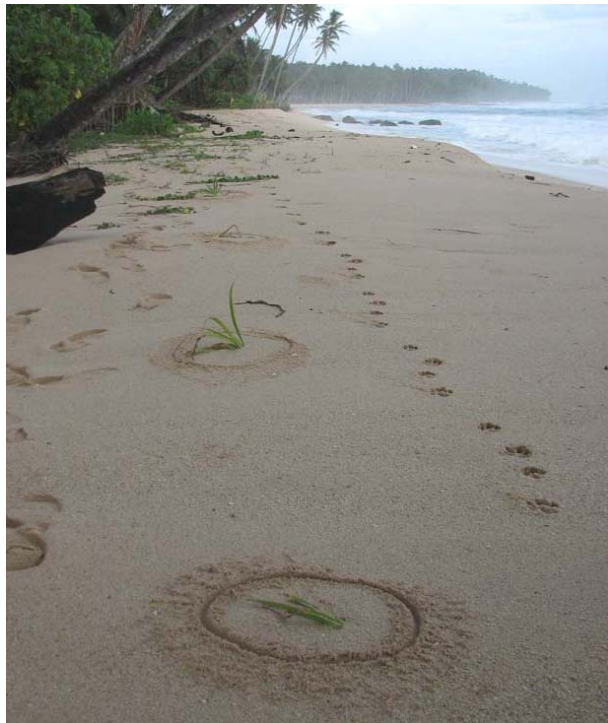
Pandanus planting program in the inter tidal zone

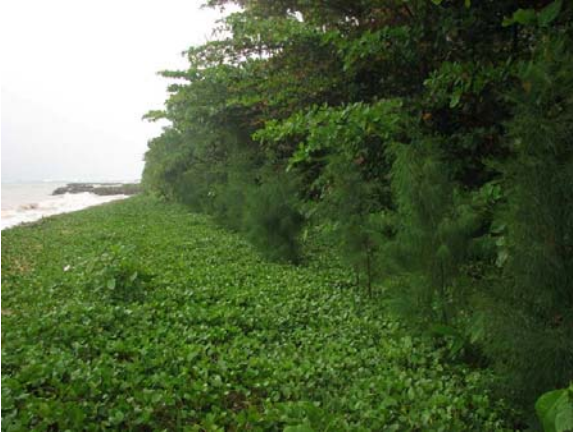
Casuarina plants in Thotamune replanting site

The implementing agency was trying to establish a 100m green belt behind the water breakers but the survival rate of the plants were as low as 10% due to the strong sea spray. Most of the plants in the 100m stretch were dead and no re-planting activity was conducted. In addition, the growth rate of the surviving plants was very slow due to the strong sea spray, high temperatures during the day and lack of fertile soil. A 150m long narrow strip of plants was established beyond the water breaker wall and plant species such as *Pandanus odoratissimus*, *Terminalia catappa*, *Accacia sp.* and *Casuarina equisetifolia* were planted in that stretch. These were planted on the beach and a 40%-50% survival rate was recorded in that stretch. It was also recorded that *Casuarina equisetifolia* was the only species that became well established in this site.

This is a typical post-tsunami green belt restoration project that has been conducted without proper coordination or technical guidelines. This project was a donor driven fast track project, which was conducted without any consultation from the relevant authorities. The implementing agency may only have selected the sites and planted some tree species to show their donors that they have established a green belt in the tsunami affected areas.

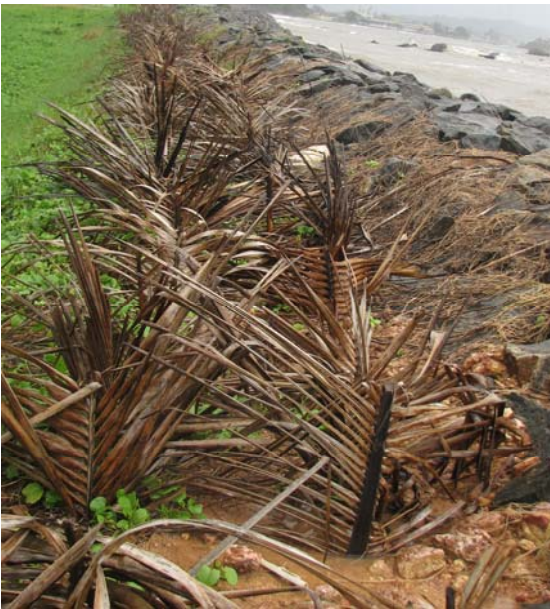
Planted area behind the break water wall, however only the cover of the plants are remaining

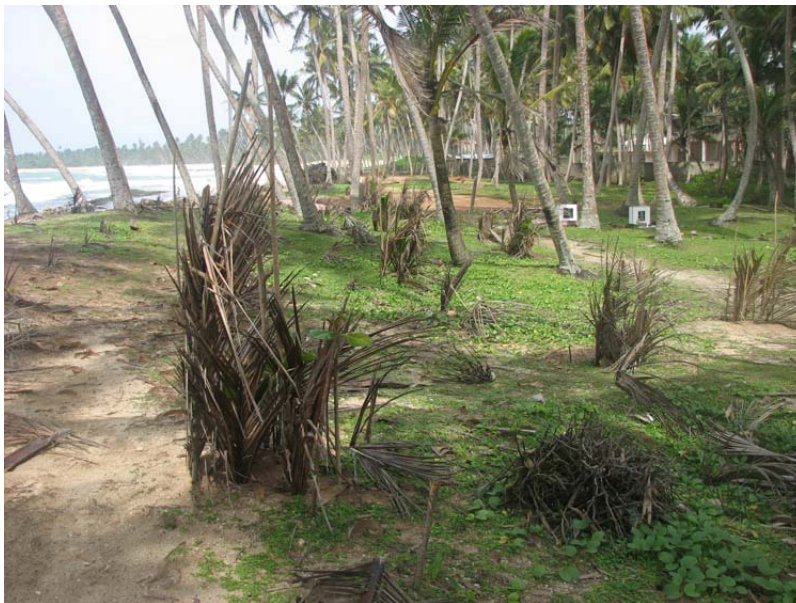
Epitamulla green belt restoration project

many agencies involved in establishing the green belt in this site, currently only the Visura Development Foundation is conducting post-planting maintenance. Most of the plants that were originally planted have been destroyed by various external factors such as tidal waves and high temperature. The Visura Development Foundation is now following the technical guidelines and conducting a fresh planting program on the green belt establishment. Plant selection was conducted appropriately and plant species such as *Pandanus odoratissimus*, *Barringtonia asiatica*, *Cocos nucifer* and *Terminalia catappa* were selected for the current replanting cycle in this site. The survival rate of the plants was as high as 50% -60% and continuing post care was observed in this sites.

Observations There was a high demand for the establishment of green belts after the tsunami, due to the large number of donors who were willing to provide funds. This site is a good example as many organisations have repeatedly conducted the same activities on the same site without much success. The success of these initiatives depends totally upon technically sound implementation, as well as post maintenance until the plants become well established; which is what most agencies failed to follow.
