Completion Report Establishment of Integrated Water Resource Management, Qila Iskan Khan, Pishin

Preamble and Background

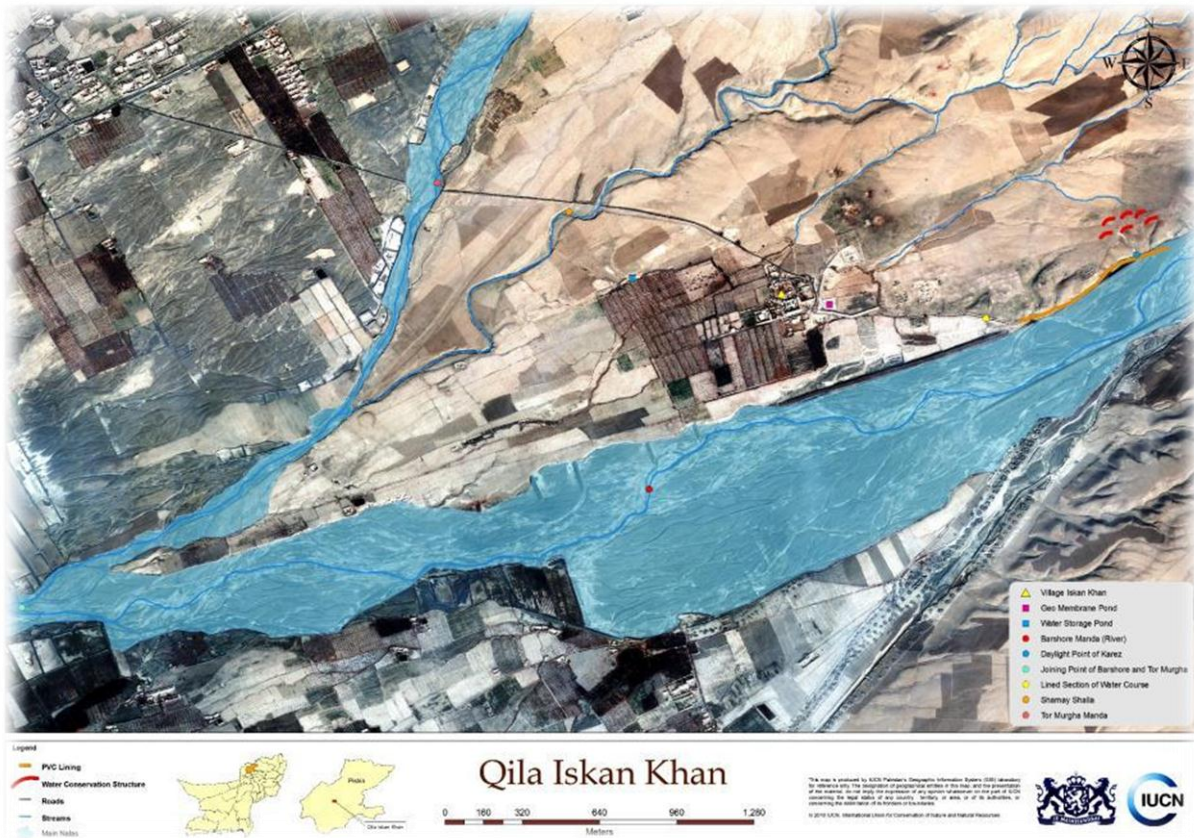
The topography and other salient features of the area are given in Fig-1.. However, in simple narrative terms, the village is located 28 Km north east of Pishin City at (30° 43' 54"N; 67 ° 09' 18" E) at an elevation of 5368 feet above sea level. The

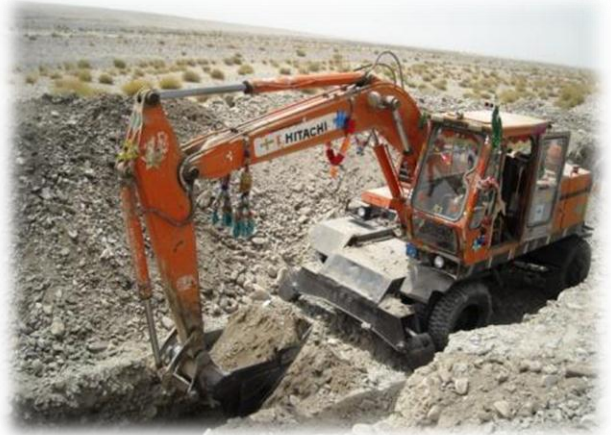
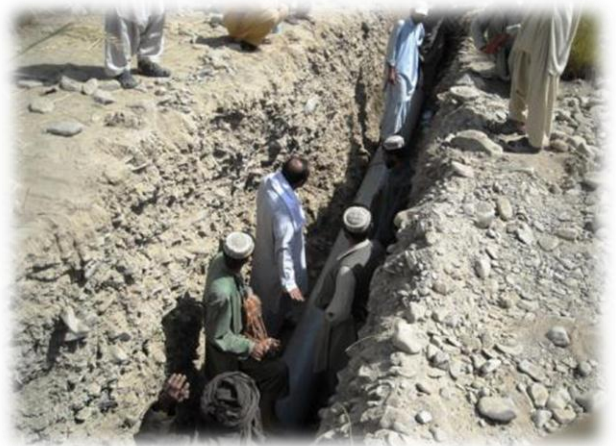
As identified at the inception of the project, the critical portion of the main channel streaming out the karez was rehabilitated using 14” PVC B-Class pressure pipe. Prior laying of PVC pipe, the watercourse was excavated by the community using labour and machinery. Thereafter, the pipe was laid by the community itself. Not only this, the community also provided 20% funds for procurement of PVC Pipe and accessories. In addition to above mentioned works the community took the liberty of constructing a manhole at the daylight point of karez.

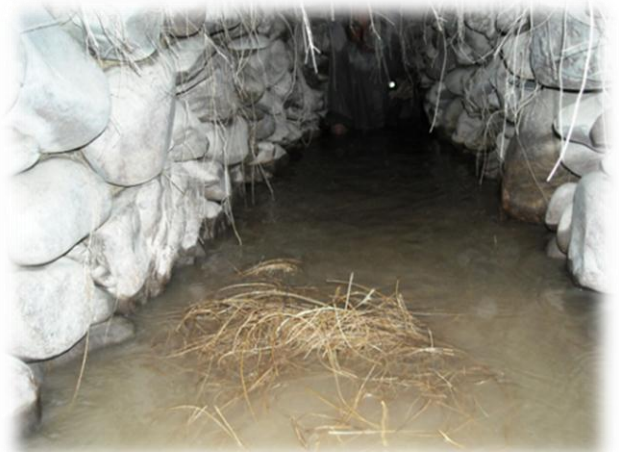
After successful installation of PVC line, the community carried out the cleaning work of main channel at the upstream side of day light point. Though it was not only a hard task but the zeal of the community made it possible in merely 13 days. Resultantly, a total of 1200 meters

of main channel was cleaned by the community. IUCN provided 50% cost of labour whereby, the remaining 50% cost was borne by the community itself.

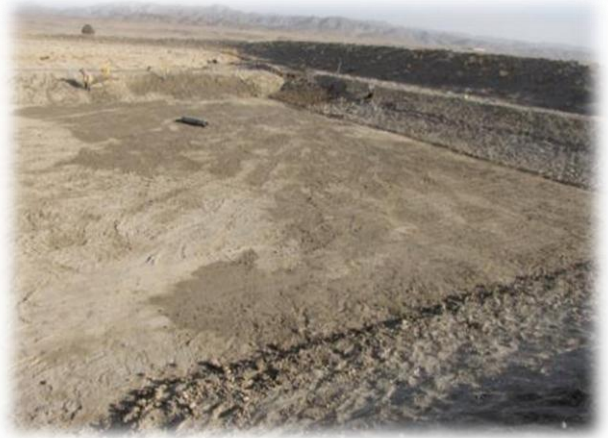
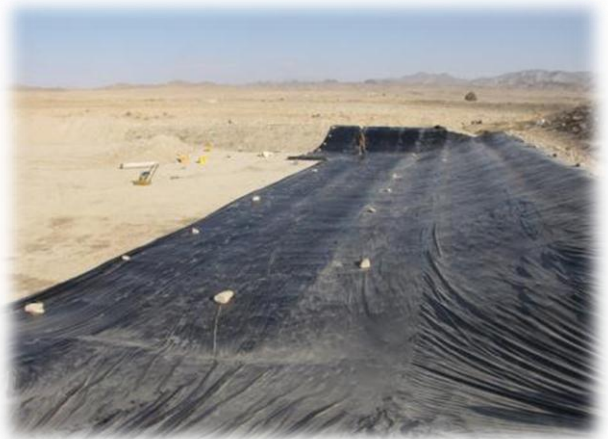
The water storage tank was constructed in 3 steps. Firstly the selected site was cleaned by the community and after that the earth was completed as per design provided by the BPSD Technical staff. The community deployed labour and tractor for construction of the Water Storage Tank. Once the earth was complete the community under direct supervision of BPSD technical team lined the bed and banks of the water storage tank with Geo-membrane. The lined section was then covered with 1' sieved earth so as to protect the geo-membrane from direct sun.

The job was completed in 14 working days using 12 labour and 32 Tractors working hours.

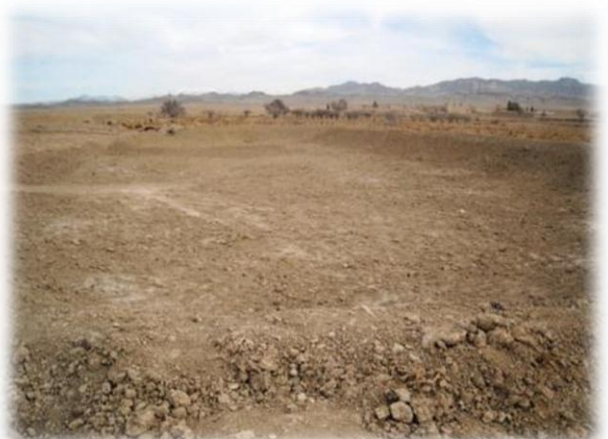
This particular water storage tanks was also lined with geo-membrane but prior spreading of geo-membrane on its banks and bed, the water storage tank was cleaned by the community and the side banks were re-constructed using tractor as per design. After

completion of earth work, geo-membrane sheets were spread on the bed and banks of the Water Storage Tank. The entire lining was then covered with 1' thick earth layer to protect the lining from sun and other possible failure threats.

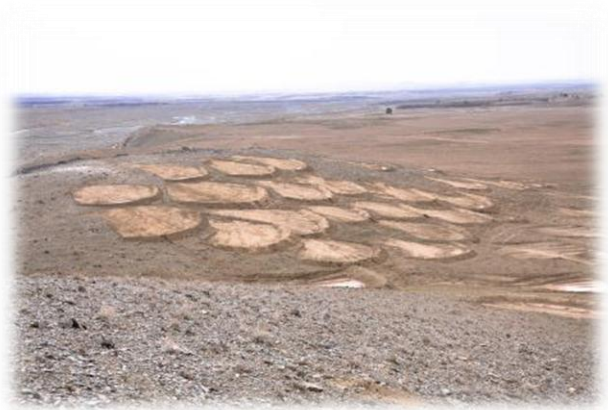
80 eyebrows like check structures were constructed using labour and tractor at the up-stream side of the karez with a view to offset the runoff during rains and ensure ground water recharge in the catchment area along with increase in vegetation.
